# Pioneer Cottage Buderim

## Conservation Management Plan

June 2019

| Document Title | Conservation Management Plan for Buderim Pioneer Cottage |

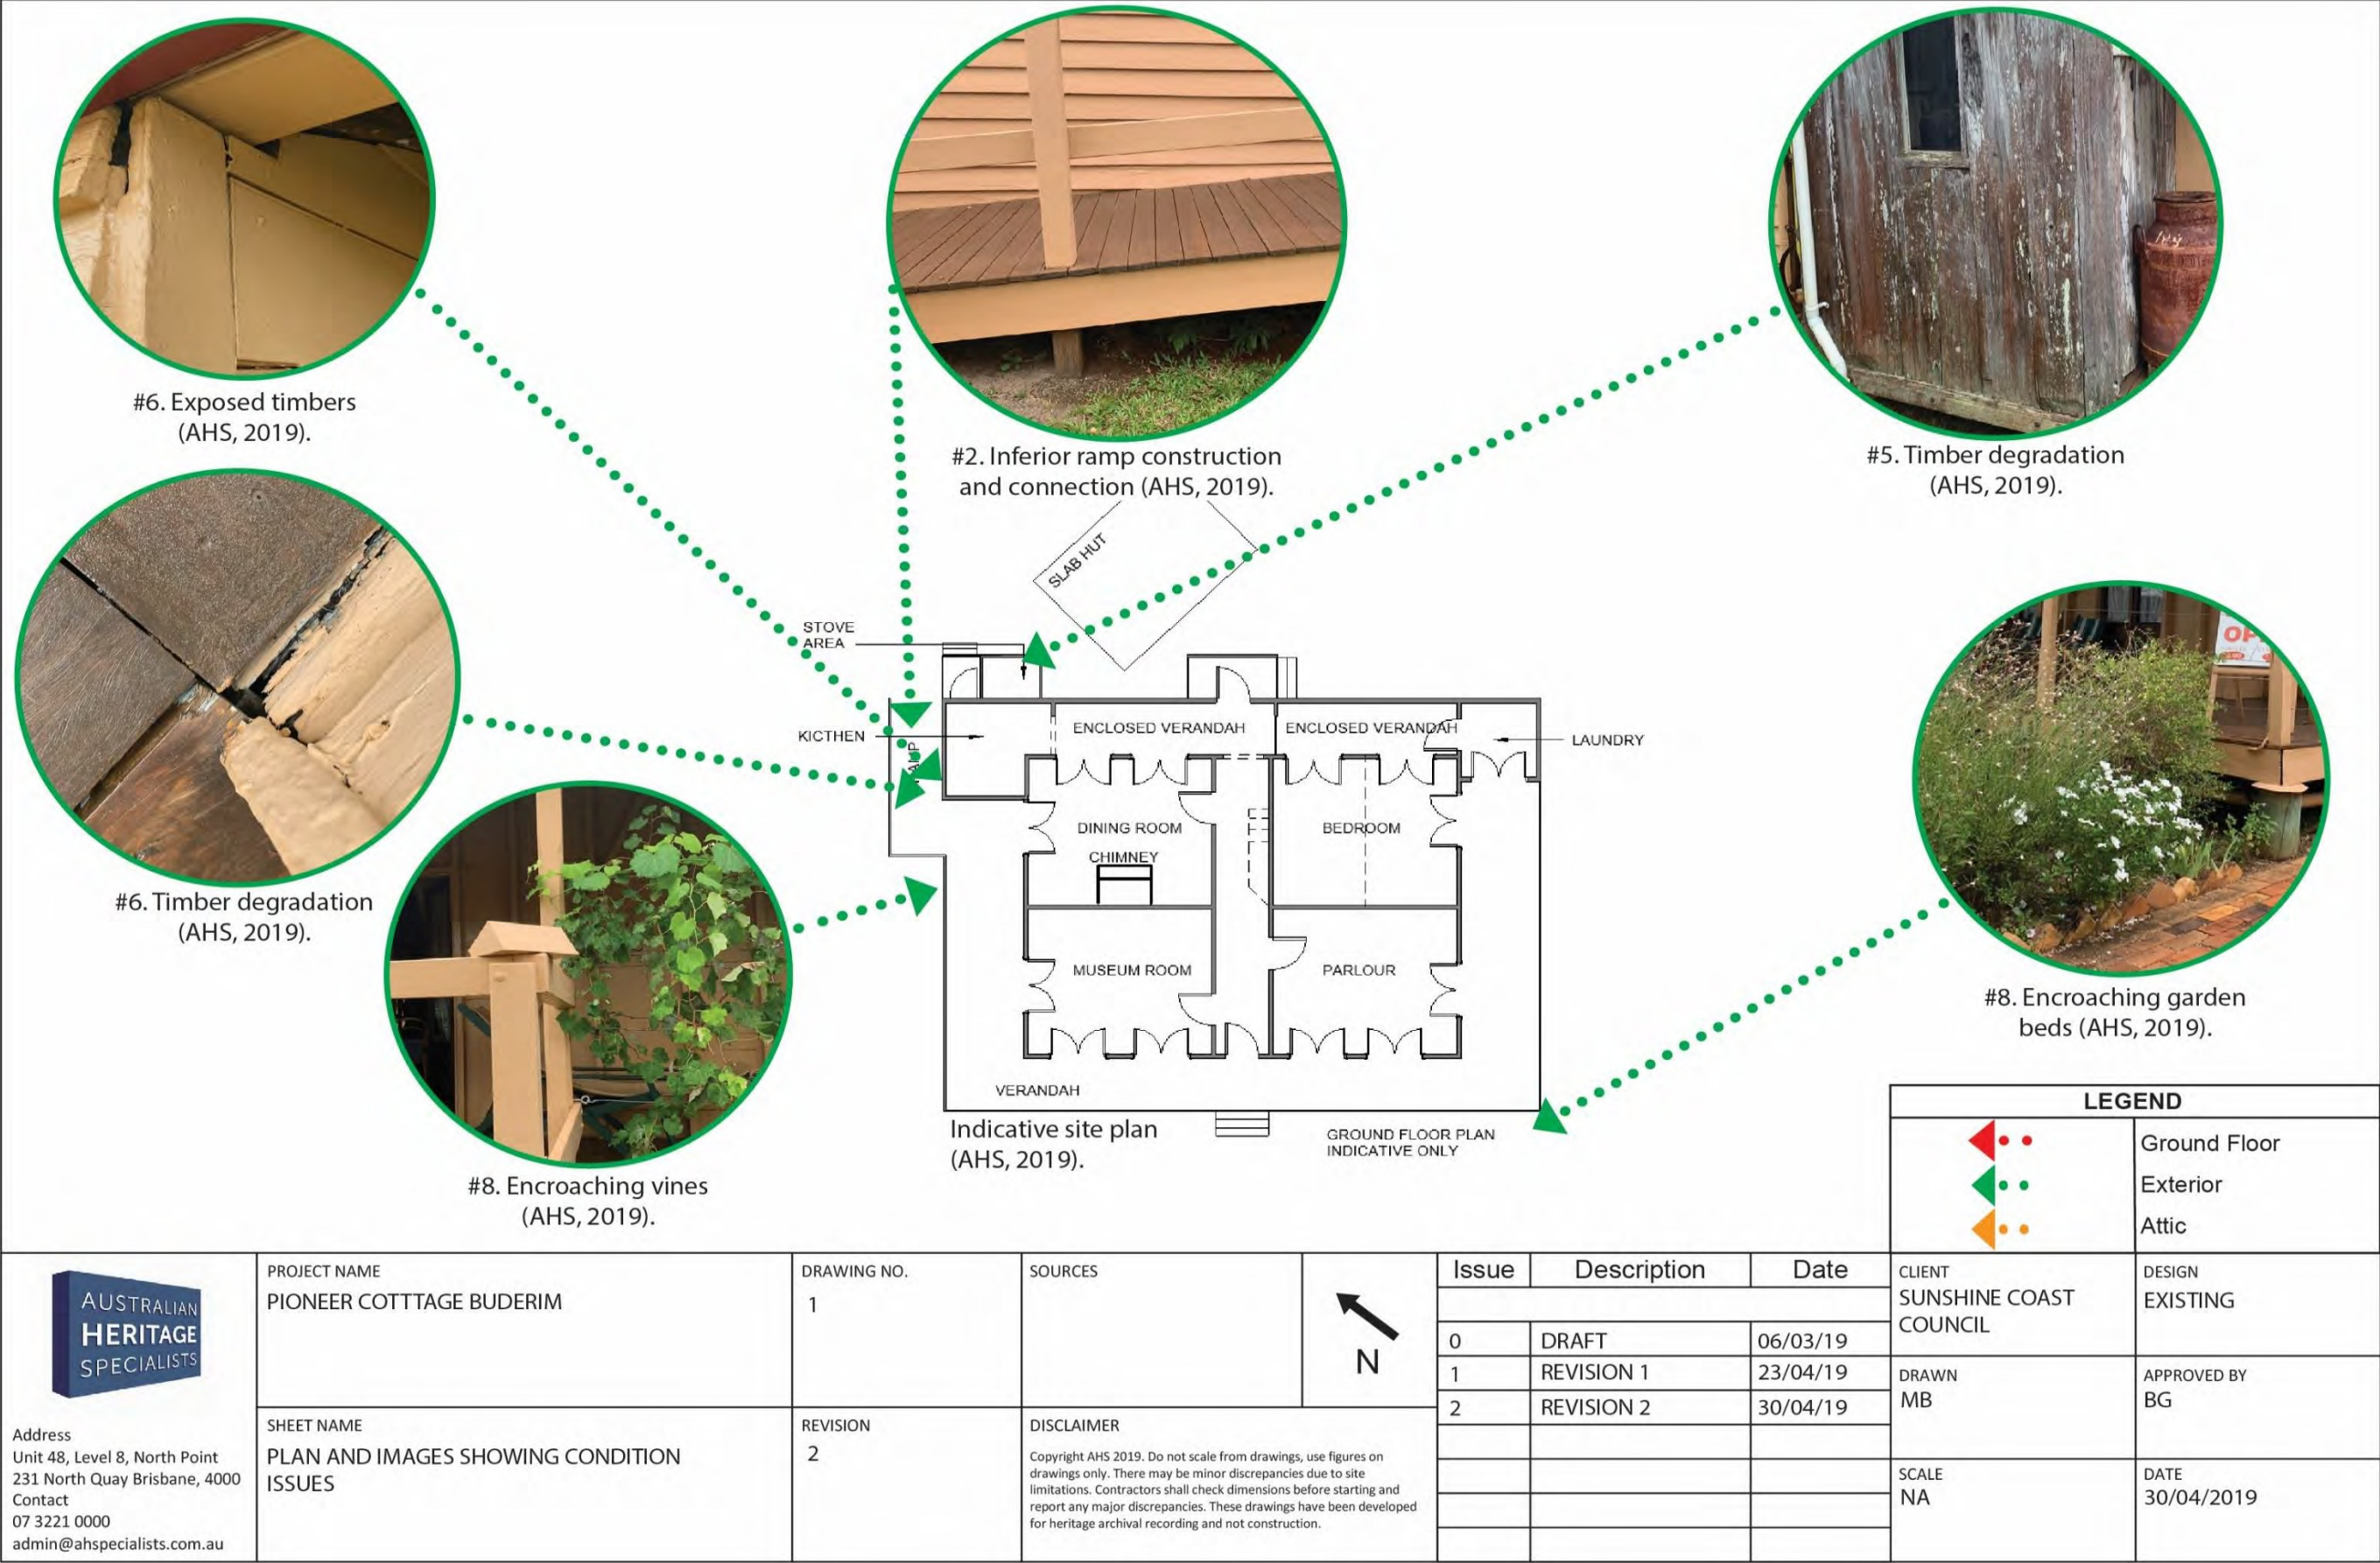
| <b>Figure 67:</b> Plan and images showing condition issues 1 (AHS 2019) ..... | 39 |
