# Pioneer Cottage Buderim

## Conservation Management Plan

June 2019

| Document Title | Conservation Management Plan for Buderim Pioneer Cottage |

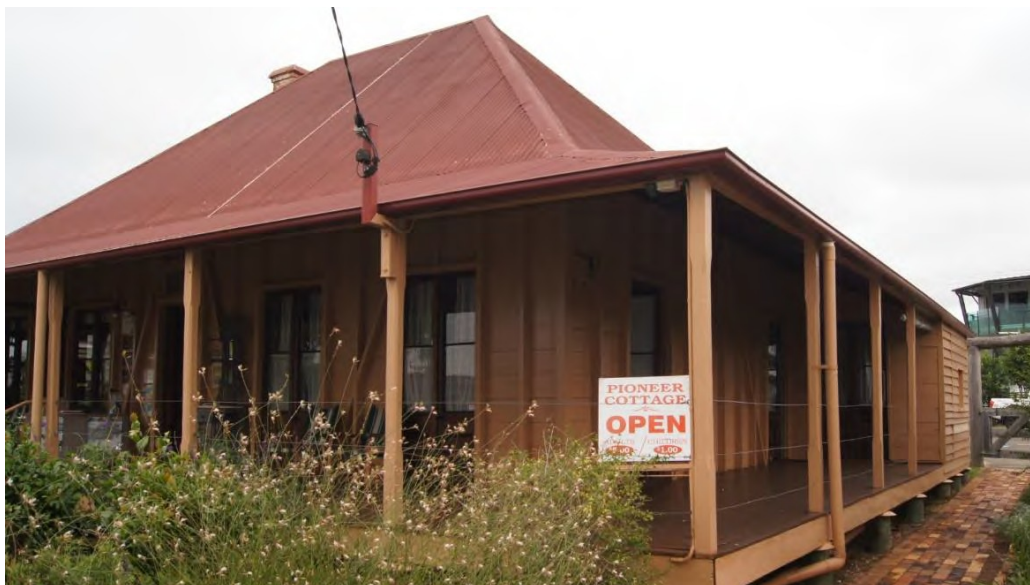
**Figure 23:** South western side of the roof showing chimney and barrel roofed dormer windows with hoods (AHS, 2019).

| Element | # | Condition/Observation |
|---|---|---|
| Roof | 1 | There is evidence of a large roof leak along the south western side of the cottage. This has caused: <ul style="list-style-type: none"> <li>Water damage and falling damp in the south western ceiling and wall of the dining room.</li> <li>Leaks above original boarding and external braces of the north eastern wall of the 1930s enclosed verandah adjoining the dining room.</li> <li>Damp in the south western ceiling and wall of the rear bedroom.</li> <li>Leaking roof above the dormer windows in the attic.</li> </ul> |

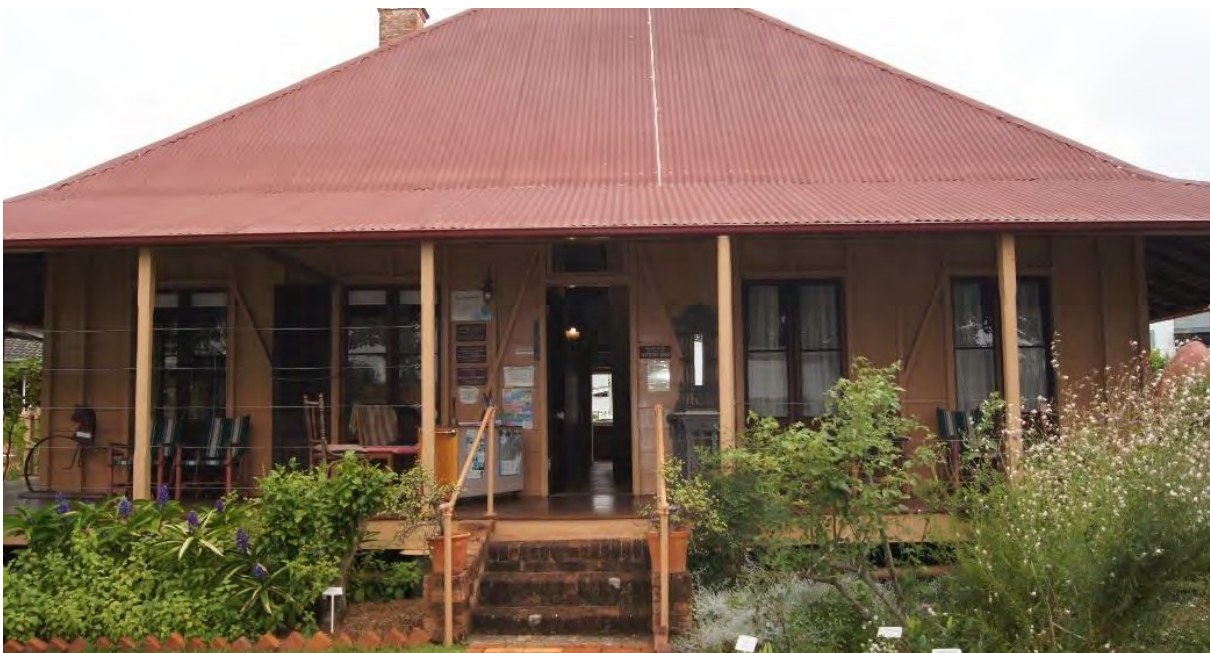
**Figure 26:** Original brick chimney with contemporary iron chimney cap (AHS, 2019).

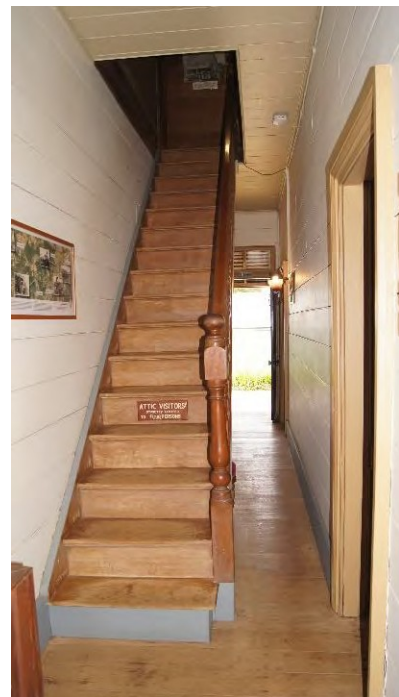
**Figure 36:** Stairway into the attic showing wooden stair treads and balustrading (AHS, 2019).

| Element | # | Condition/Observation |
|---|---|---|
| Internal stairs | 12 | The softwood treads of the stairs show wear and tear from prolonged use. |

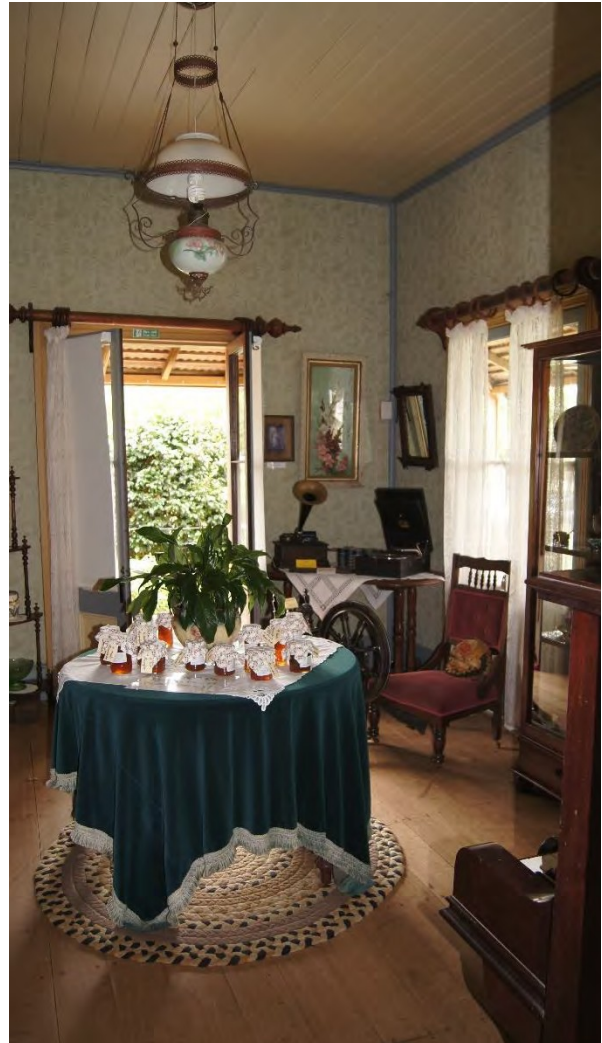
**Figure 38:** Parlour looking towards the north western verandah (AHS, 2019).

| Element | # | Condition/Observation |
|---|---|---|
| Parlour Walls | 7 | The wallpaper in the parlour has cracked due to the natural movement of the cottage and the shrinking and swelling of the timbers and plaster linings. |

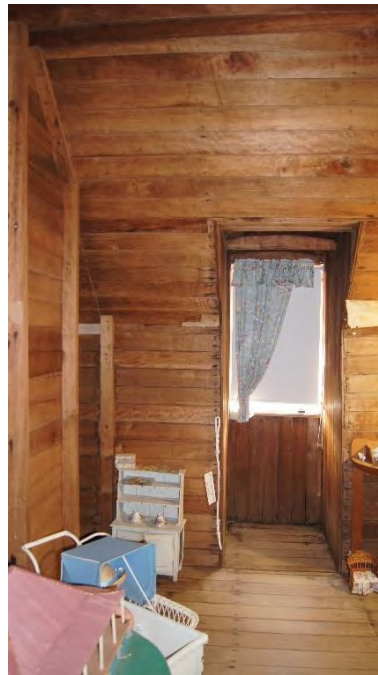
**Figure 63:** Dormer, double hung sash window along the south western wall of the attic (AHS, 2019).

| Element | # | Condition/Observation |
|---|---|---|
| | 4 | The interior dormer windows, window sills and walls show evidence of timber degradation and water damage due to leaking flashing and screws. |

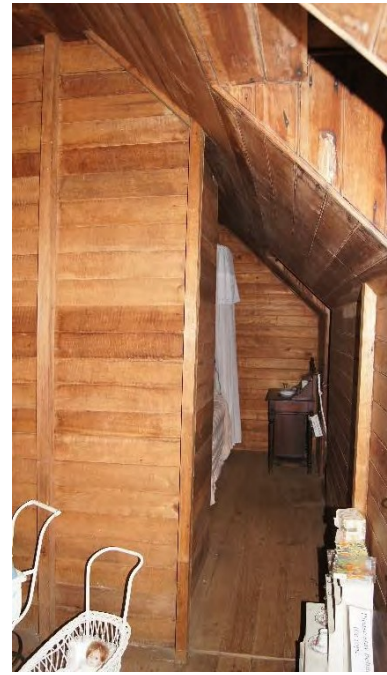
**Figure 64:** Throughway along the south western wall of the attic (AHS, 2019).

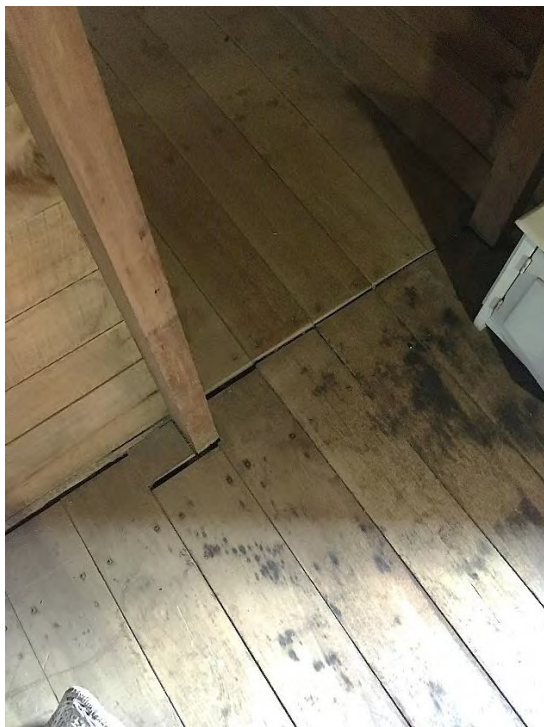
**Figure 65:** Wall stud of attic joined to lower floor wall stud (AHS, 2019).

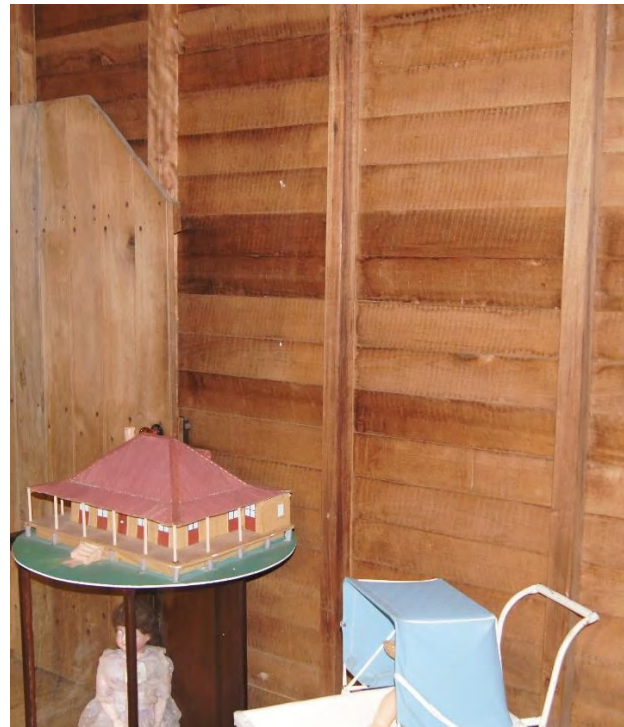
**Figure 66:** Exposed studs on the stairway's north western wall (AHS, 2019).
